**Full Vision, Inc.**

**MEDICAL GRADE TREADMILLS**

## **URGENT MEDICAL DEVICE CORRECTION**

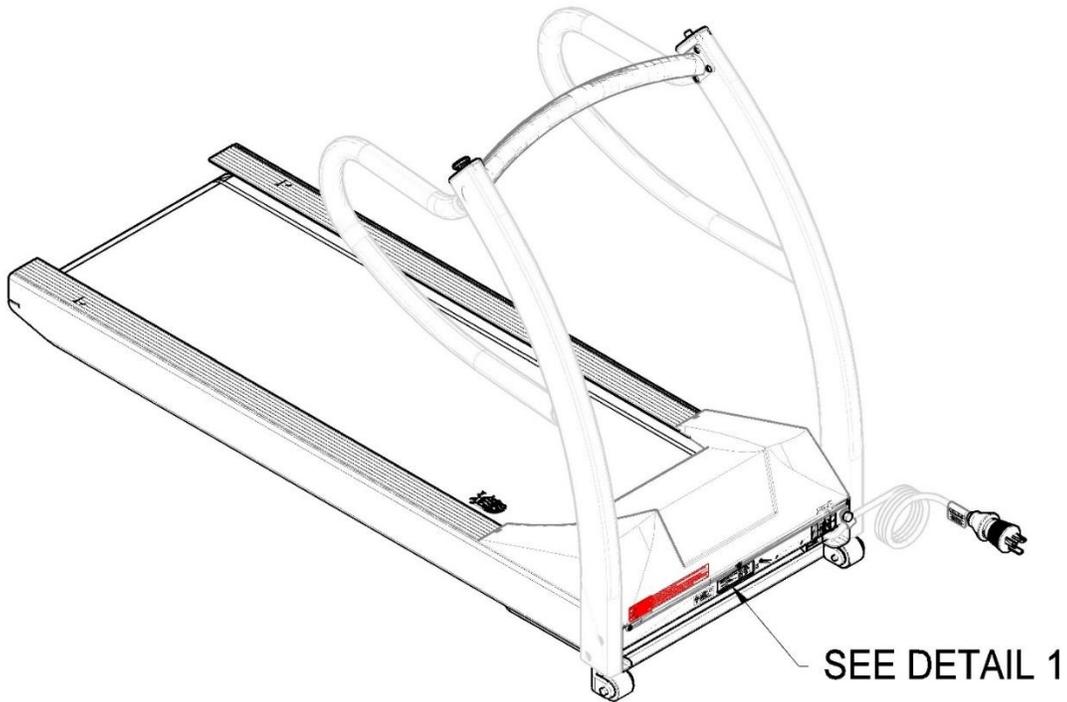
DETAIL 1

See Appendix A for location of decal. Serial numbers are located on the front of the device.

See images below for reference to identify the serial # of your device(s).

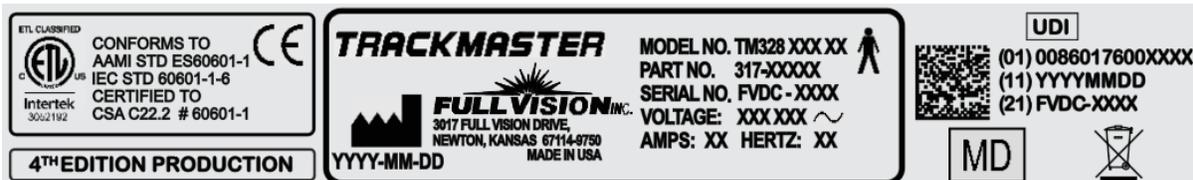
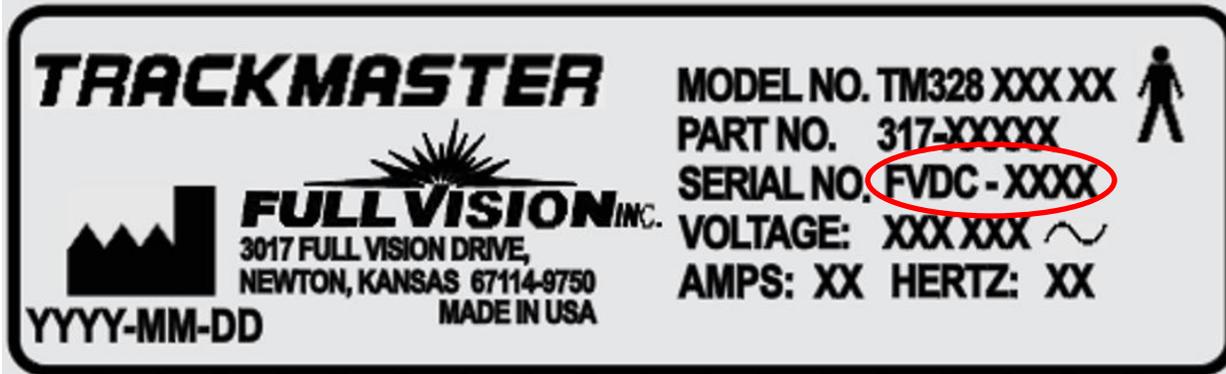
Enlarged image of serial number decal
